User Guide

Thank you for investing in our ProMAXX® EGR Valve Tube Repair Kit (NINO). This device was engineered to facilitate a repair, versus replacement of the manifold in the Ford 6.7L diesel engine saving you time and your operation unnecessary cost.

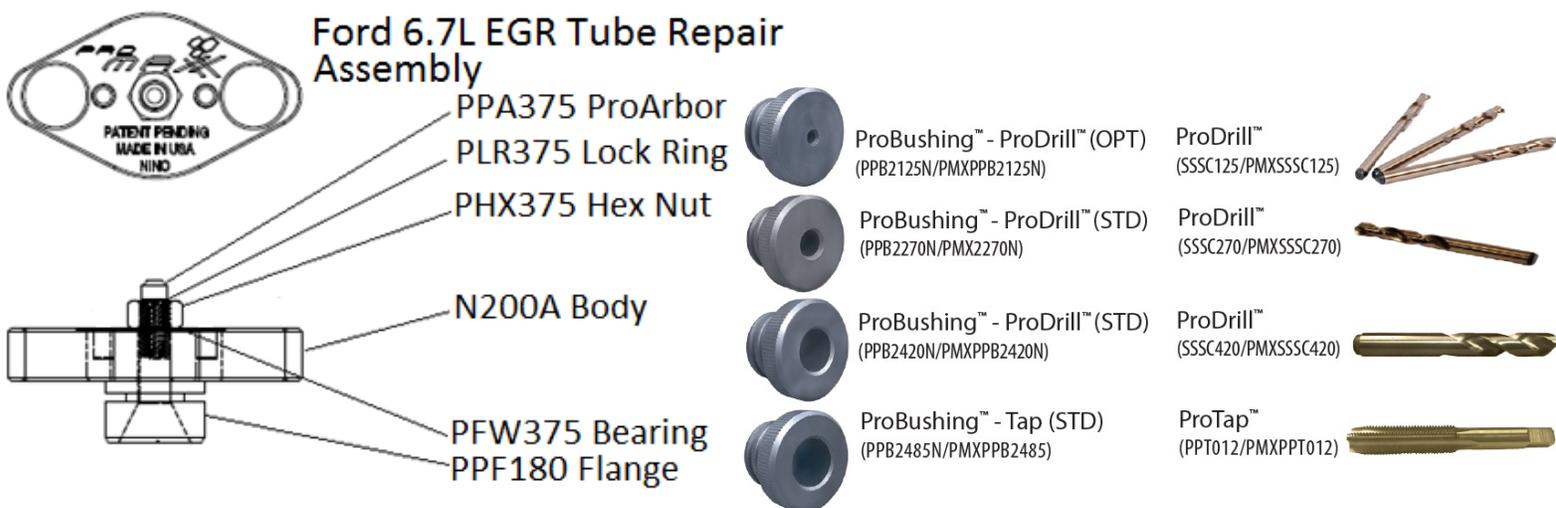
Tools required: Pneumatic or electric drill ½" diameter capacity. Plastic faced hammer, steel ball-peen hammer, 9/16" deep socket and ratchet, tap holder accessory, blow gun, and OSHA approved safety glasses. Consider the optional ProBushing™ PPB125 and SSSC125 ProDrill™ machine tooling bit for a piloted start. For more rapid progress in machining, consider the ProMAXX® Platinum PLT280 and PLT420 machine tooling bits for replacement. NOTE: The fasteners used in mounting the EGR tube are extremely hard titanium alloy compound making machining difficult. Our tooling is designed to machine the fastener. However, frequent sharpening of the tooling to keep a sharp edge may be required. Maintain a cutting angle of 140 degrees. ProMAXX® does offer a sharpening service to return your machine tooling to optimal performance. Visit our website at www.promaxxtool.com for details.

It is recommended that the intake manifold should be removed and subsequent aluminum housing if attempting to repair the bolt closest to the intake, otherwise, leave the intake manifold intact. Protect all air intake passages from cutting debris before performing any machining operation. Remove any remaining portion of the fastener that protrudes above the surface of the exhaust manifold prior to mounting the NINO™ ProBody™. Insert the ProBody™ PPF180 flange side to the exhaust manifold via the EGR valve tube exhaust passage carefully centering the two bushing mounting holes over the 6MM tapped hole/damaged bolt(s). If only one bolt is broken, use the optional ProPin™ PPP750 for aligning the tool precisely over the damaged bolt. Using a 9/16" deep socket and ratchet tighten the chrome hex nut PHX375 until the ProBody™ stops moving. Once stable, turn an additional one-quarter to one-half turn of your ratchet securing the ProBody™ to the manifold – DO NOT OVERTIGHTEN. Insert ProBushing™ PPB280, or for a faster stepped repair, the optional PPB125 into the ProBody™ over the damaged bolt. Once set, select the proper ProDrill™ SSSC125/SSSC280 or optional ProMAXX® Platinum machine tooling bit and insert it into a ½" capacity air or electric drill. NOTE: Be sure to regulate drilling speed to approximately 200 RPM, not exceeding 300 RPM for the SSSC280/420, or Platinum, and 500 RPM for the SSSC125 tooling bit or damage to the tooling bit may result. Select the ProStop™ PPS280 collar in the kit and slip it over the SSSC280 machine tooling bit and set the amount of the bit protruding (distance) between the bottom of the collar to the tip of the bit to 1 11/16". Tighten the ProStop™ socket head screws to secure it. Check the ProStop™ to ensure it is tight and will not move. Apply two drops of ProMAXX® ProLube™ specially formulated cutting oil to the bushing and to the bit and manually turn your drill chuck until the tooling bit rests on the damaged bolt. This will ensure precise fit and preserve the tooling cutting edge. Toggle your drill on and off five to ten one-second intervals applying light pressure on the drill. This process will allow the cutting edge to engage in the cutting surface prolonging bit life. Once complete, begin drilling continuously until the ProStop™ rests on the ProBushing™ adding cutting oil as necessary and stopping frequently to clear debris from below the bushing and surrounding parts. Remove and replace the SSSC280 tooling bit with the SSSC420 bit, the PPB280 bushing with the PPB420 bushing, and repeat the process above. Once drilling is complete, clear all debris and insert the PPB485 ProBushing™. Attach a 3/8" drive tap holder to the ProTap™ PPT012 and apply two drops of ProMAXX® ProLube™ to the tap. Insert the ProTap™ PPT012 into the bushing, slowly and carefully turning the tap by hand clockwise ¼ turn, then counter-clockwise, repeating this process until the tap stops cutting. To prolong tap life, remove and clean debris from the tap and bushing periodically. Remove the ProBody™ assembly by loosening the chrome hex nut until it spins freely. It may be necessary to lightly tap the top of the ProArbor™ to unlock it from the manifold using a plastic-faced hammer that will not damage the arbor. Use the included insert tool to thread the PPS006 ProSert™ into the manifold until it stops. Lift the insert tool slightly, turn it 90 degrees and tap the top of the insert tool with a ball-peen hammer to drive the locking pins flush with the surface of the manifold. Once locked, the manifold is now permanently repaired. ProMAXX® recommends adding Loctite® anti-sieze compound to the fasteners when re-installing the EGR tube.
