Optional Extractor-less Repairs

Ford Gas & Diesel Application

User Guide

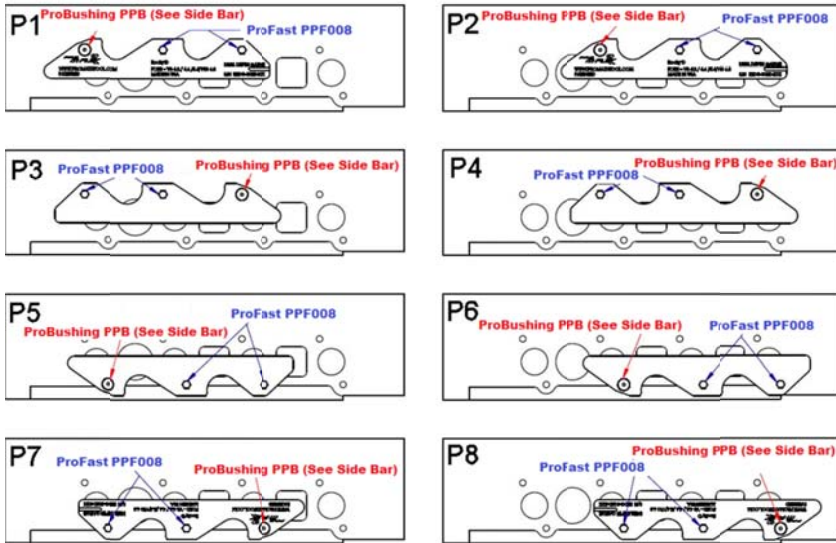
PPB2125 with ProDrill™ SSSC125 PPB2188 with ProDrill™ SSSC188 PPB2270 with ProDrill™ SSSC270 PPB2320 with ProTap™ PPT008
